febiEXAKT

Triangular control arm

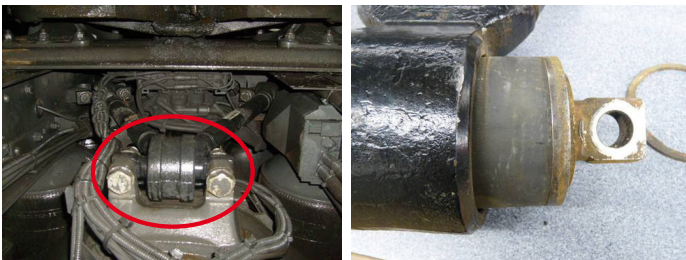
Premature failure of the triangular control arms central bearing.

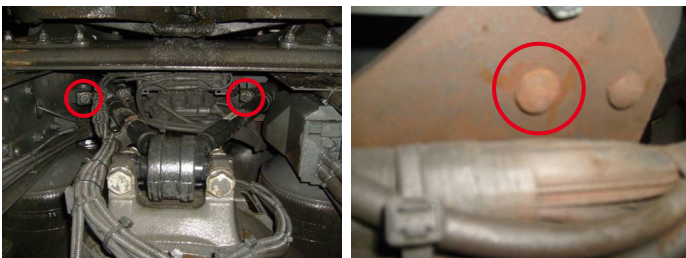
Both bearing mounting brackets which link the triangular control arm to the chassis are joined to the chassis via mounting plates. The mounting plates are attached to the frame with rivets. The components referred to are subject to significant stress during loading and unloading and this applies even more if the truck is overloaded or road conditions are poor.

These loads can lead to the rivets working free. The bearing mounting bracket which is joined directly to the triangular control arm may exhibit play due to the lost rivets. Even a minimum amount of play is enough to transfer additional forces to the central bearing. The central bearing, however, cannot withstand these unforeseen loads and fails as a result of the additional stress.

Check the mounting plates before fitting a new triangular control arm. If a rivet has been lost, it can be replaced with a screw. This screw is sufficient to minimise the play and the central bearing will again be subjected only to the forces for which it was intended. febi bilstein recommends the use of febi 26709/26710 threadlocker for maximum hold. The liquid plastic which cures in the absence of air prevents re-lease or loosening of the threaded joint between screw and frame even under the most severe operating conditions.
